Beloit Historical Society
845 Hackett Street
Beloit, WI 53511

Condition Report for 845 Hackett Street, Beloit Wisconsin

Angus-Young Associates
555 S. River Street - Janesville, WI 53548
7/27/2016

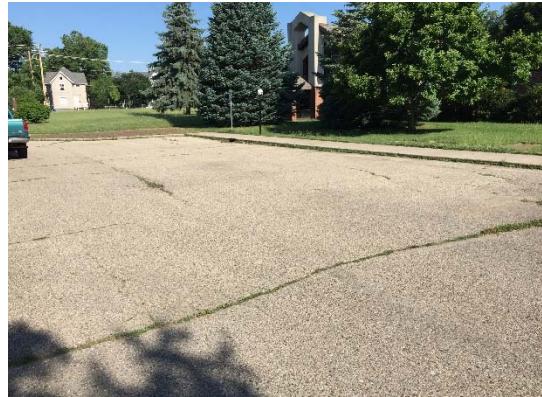
Figure 3 - Driveway Pavement Cracking

The driveway and front parking lot pavement have some longitudinal and transverse cracking and there is one pot hole in the front parking lot. See figure 3 and figure 4 for pictures of the driveway and front parking lot pavement.

- Replace parking lot pavement and restripe parking stalls
- Fill joints of brick pavers with sand or replace paver section
- Add detectable warning field to handicap ramp figured 10
- Shape ~600 sq. ft. of existing ground to drain away from building at vestibule and West side of building

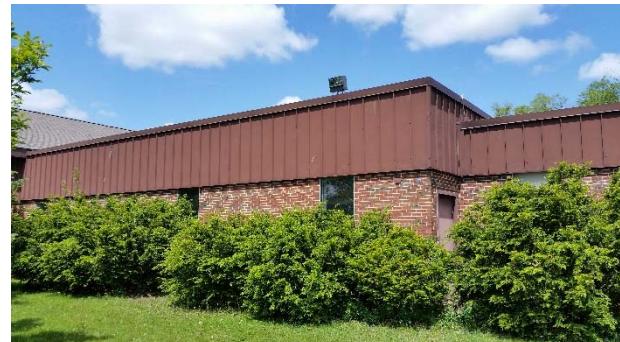
A-8: 1971 addition facade

Likewise, there are five small single pane aluminum windows in the 1971 addition that are beyond their useful life (ph A-8). These are less thermally efficient than the aluminum windows in the 1989 addition, but given their small surface area, they are likely not leading to large heat losses. Replacement may be considered in upcoming budgets.

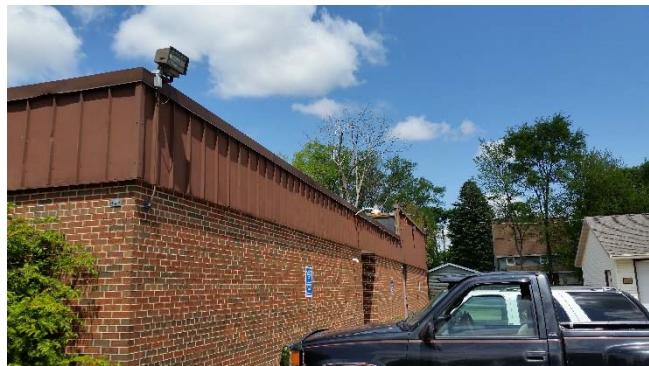
A-9: No Brick Coursing

The exterior façade for the 1971 addition looks to be in decent shape. A metal fascia panel and coping comprises the upper third of the wall surface. This metal paneling, although older and dented in a few locations, has stood the test of time and appears to still be in decent shape. A fresh coat of paint may be considered to freshen the aesthetic (ph A-8). The brick (with the exception of one corner) is in good condition. The exterior brick is tied to the block wall back up with tie back brick coursing at every 6th course (ph A-9). This type of construction is known as composite wall

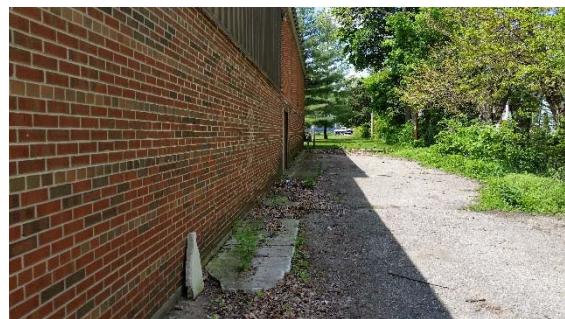
A-10: Brick Stains at lower coursing

construction. The lower course of brick along the North wall are slightly stained. It appears that the site in this area is not properly graded to shed water away from the building and may have been prone to flooding at one point (ph A-10). Re-grading this area should be considered in the future to prevent wall damage. The brick in this area could likely be cleaned and doesn't appear to be damaged.

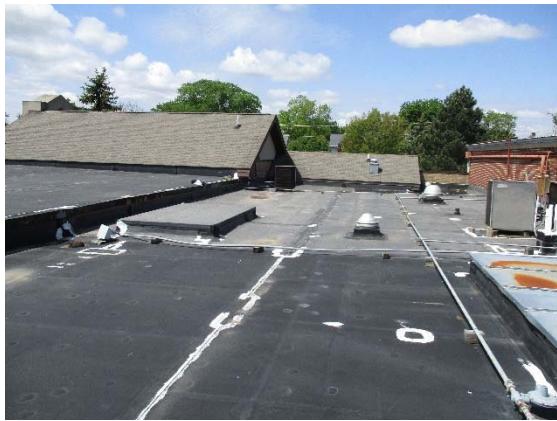
A-19: Re-roof (lighter is newer)

room (ph A-17) and asphalt tiles/ rubber roofing over the exhibits room (ph A-18). In general, the EPDM roof was in decent shape. There was a partial re-roof of the EPDM membrane completed back in 2005 or 2006 (ph A-19). A typical EPDM roof can have a lifespan of 20-30 years if properly maintained. The portion of the EPDM roof that wasn't replaced appears older (20-30 year range), but is still in relatively good condition. Yearly maintenance will likely extend the life of this roof. A roof replacement should be considered in a future budget, but likely isn't immediate in nature. That being said, to extend the life of the roof, the roof is in need of maintenance. As noted in the next section, some of the roof drains need to be re-flashed to eliminate water infiltration, the drains need to be cleaned (currently clogged with debris), the EPDM joints should be re-sealed in several areas (ph A-20) and finally a cleaning of the roof will prevent future scaling of the EPDM surface.

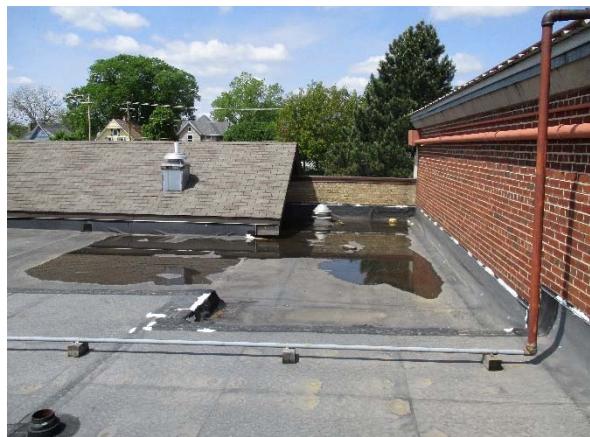
A-21: Standing Water

standing water. These areas should be cleaned and raised to prevent roof damage and extend the life of the roof.

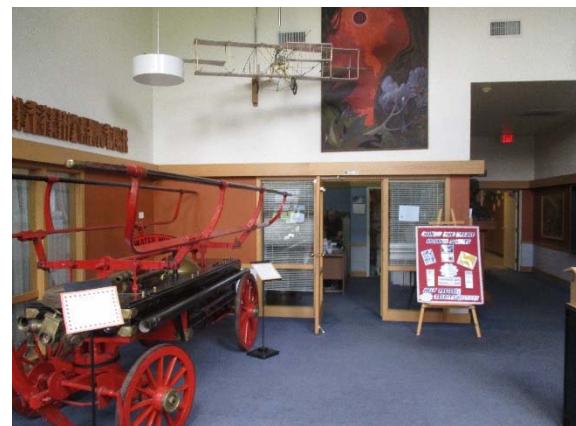
A-28: Main Lobby

The main lobby and offices appear to be in decent shape (ph A-28). As mentioned earlier, there are some moisture issues that need to be addressed where the roof is not properly flashed. Some of the window sills show signs of this moisture infiltration (ph A-30). The carpeting throughout this area is past the useful life of carpet and showed wear patterns (ph A-29). The ceilings are in good shape with no signs of major cracking. The attic space looked dry with no signs of major water infiltration. New carpeting and fresh paint could be considered in the future to modernize the aesthetics of the space.

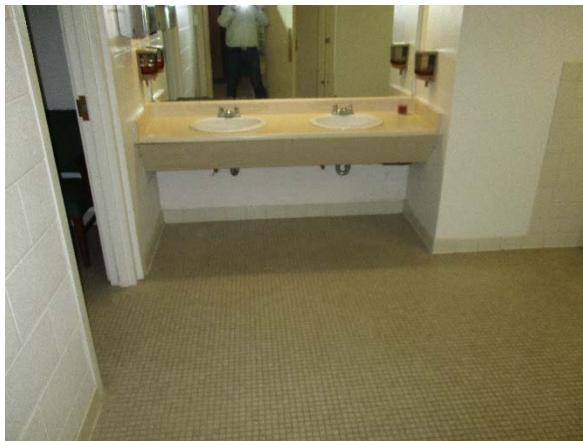
A-33: Restroom finishes/ counters

The tiling in both bathrooms appears to be original to the 1989 addition and is composed of 1" x 1" square tiles (ph A-33). Replacement of this flooring may be considered in future projects to freshen the look. The ceiling grid and tile are stained and also may be considered for replacement (ph A-34). The plastic laminate counters with porcelain lavatory inlays appear to be original and would not meet today's standard for accessibility (ph A-33). Code mandates that the lavatory surface can't be more than 34" above the floor and a minimum knee space of 27" is required below the lavatory surface.

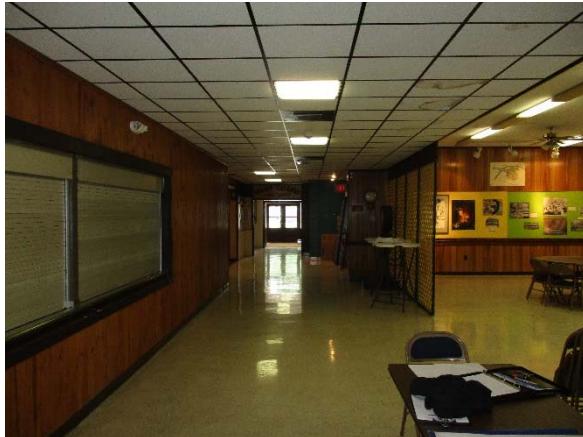
A-39: Corridor finishes

Likewise, the Vinyl Composite Tile (VCT) in the corridor, community room, textile storage room and military display area should be checked prior to renovating (ph A-39). The lay-in ceiling down the East corridor is stained in several areas below the main heating supply duct. A roof leak, through capillary action likely followed the

HVAC duct and stained these tiles along this path (ph A-39). This ceiling should be considered for replacement in future renovations. The same ceiling tile is carried into the military display room. It should be replaced at the same time the corridor ceiling is renovated.

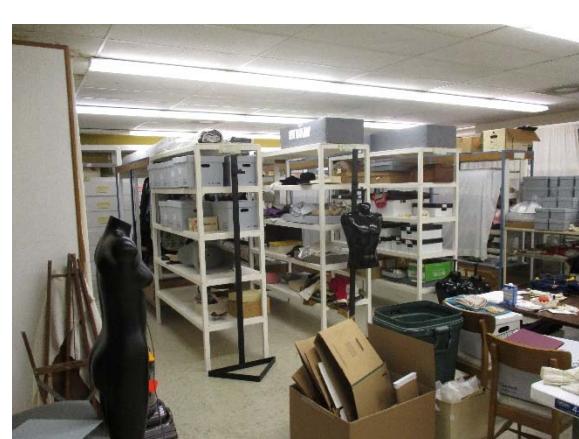
A-42: Textile storage room finishes

Off of the East corridor, is the textile storage room with V.C.T flooring and a lay-in ceiling. In several spots, the ceiling tiles are stained, which indicated a previous roof leak. Here again, the space above the ceiling looked dry with no ongoing roof issues. Future renovations may consider a ceiling replacement and covering of the V.C.T. floor tiling depending on the use of the space (ph A-42).

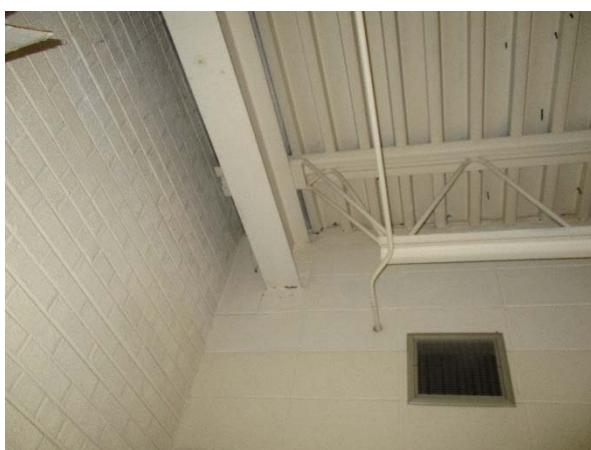
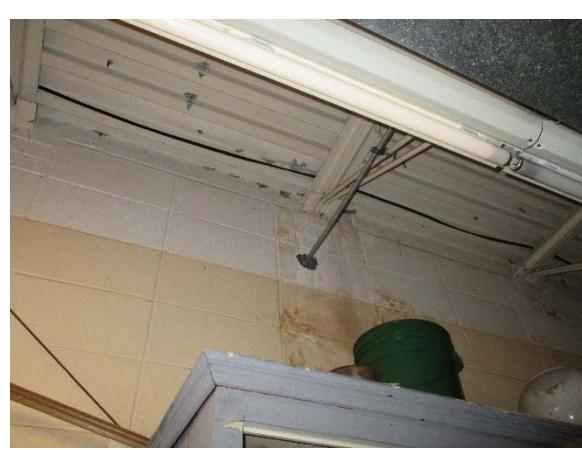
S-3: 1971 Roof structure

The 1971 addition utilizes load bearing block construction, a steel support structure and steel joists with a metal roof deck (ph S-3). The structure appeared to be intact. There were a few locations where past and present roof leaks have saturated the load bearing
