Beloit Historical Society
845 Hackett Street
Beloit, WI 53511

Condition Report for 845 Hackett Street, Beloit Wisconsin

Angus-Young Associates
555 S. River Street - Janesville, WI 53548
7/27/2016

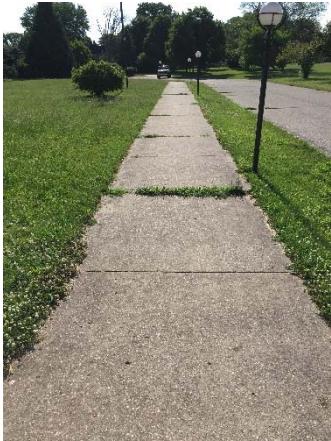
The concrete walks on site are generally in good shape. The sidewalk running from the street up to the building has no differential settling except for the first two squares are slightly lower than the rest of the concrete. See Figure 1.

Figure 1 - Concrete Sidewalk Settling

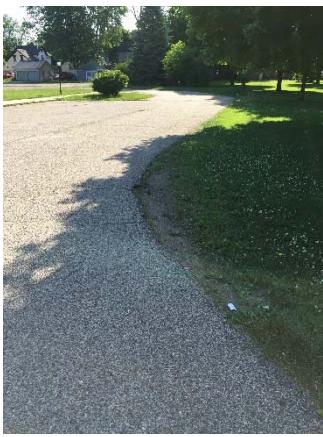
The radius on the outside edge of the driveway looks to be too tight as it appears that vehicles run over the edge of pavement through the grass. See figure 5.

Figure 5 - Parking Lot Radius

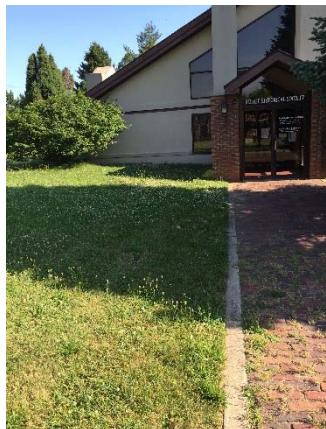
Figure 7 - Grading at Entrance

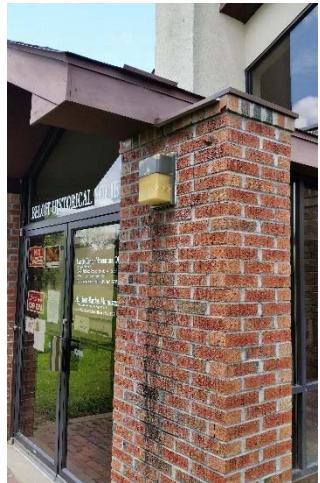
A-2 1989 Addition- South Facade

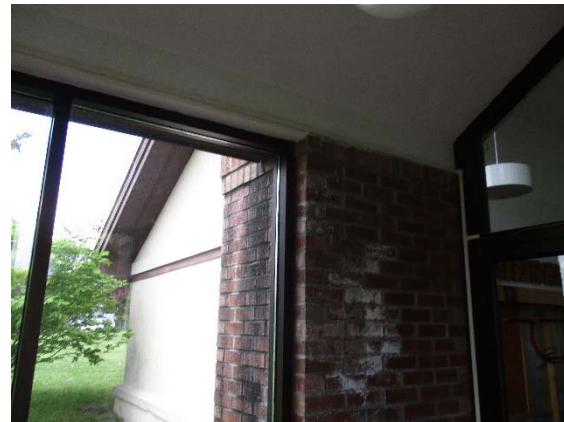
A-3: No Gutter

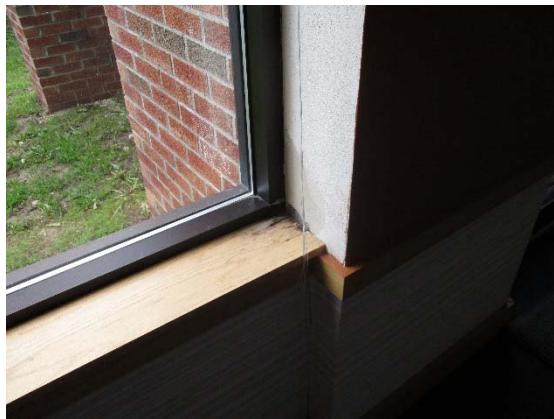
A-7: Water Infiltration

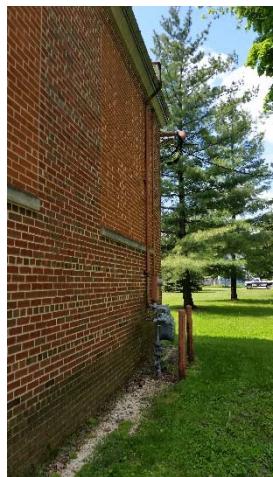
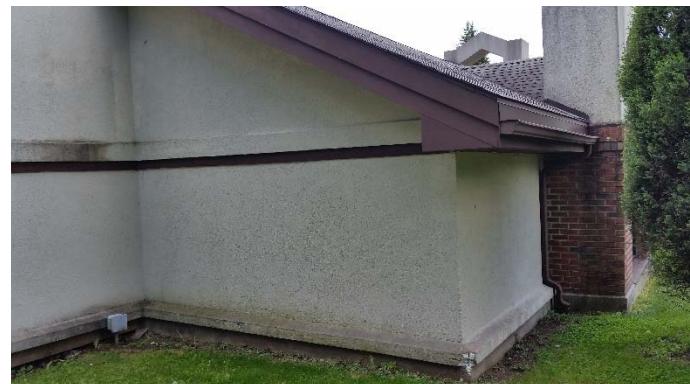
A-11: Improper flashing

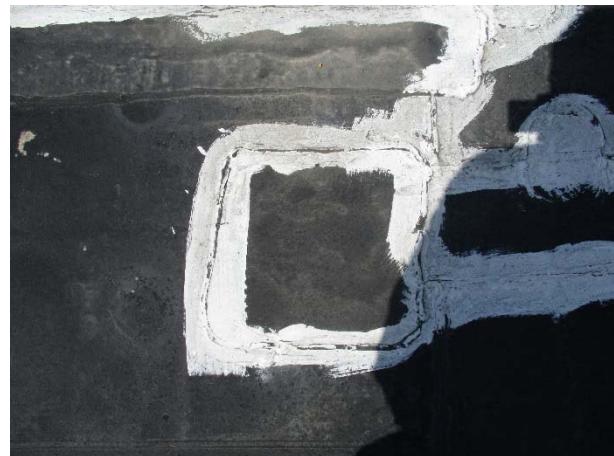
A-20: Roofing Sealant

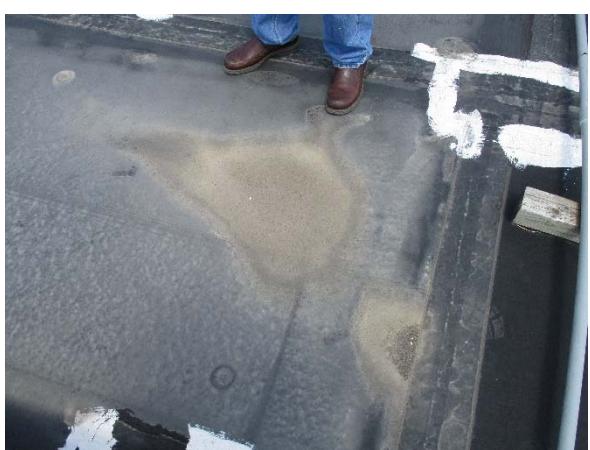
A-23: Water debris spotting

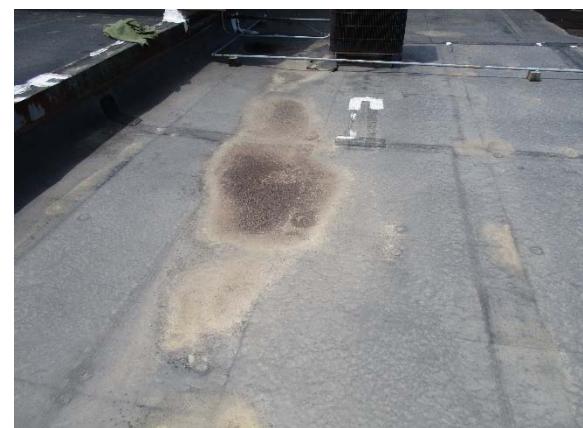
A-24: Water debris spotting

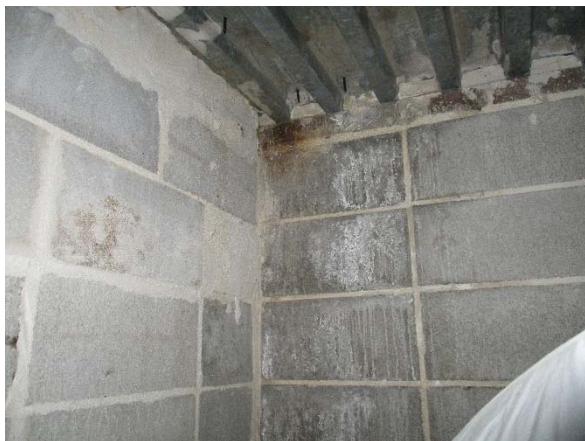
A-27: Water infiltration

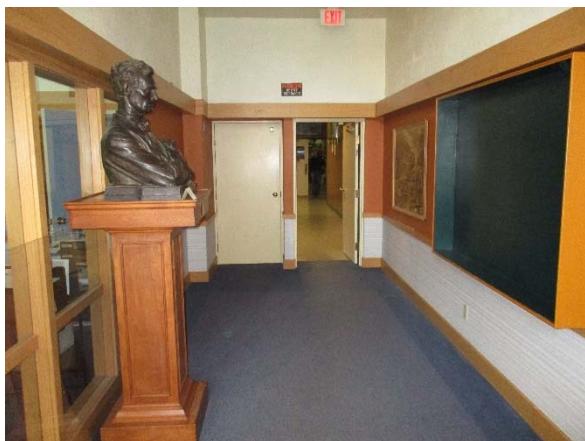
A-29: Carpeting/ wear patterns

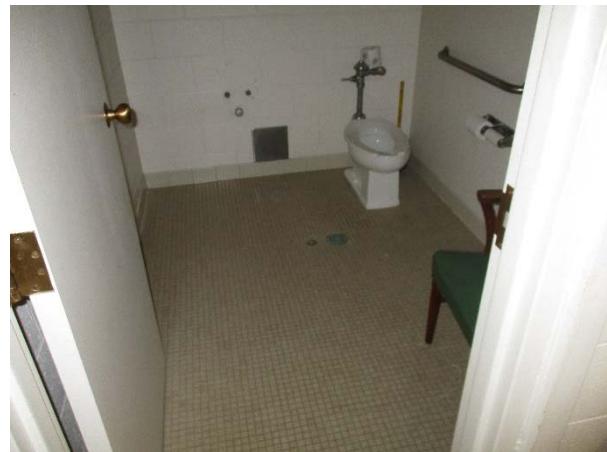
A-32: Door hardware/ grab bars

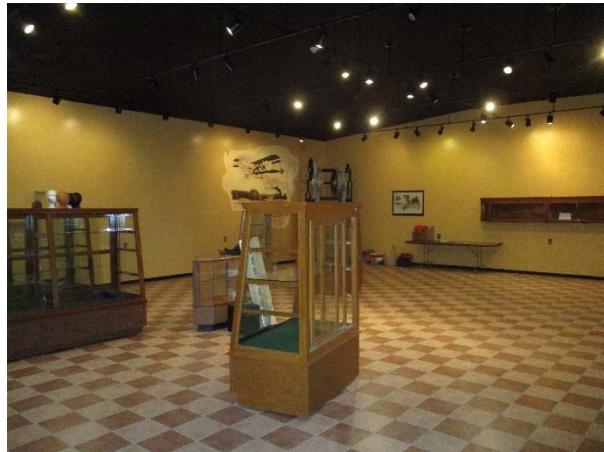
A-45: Non-compliant egress path

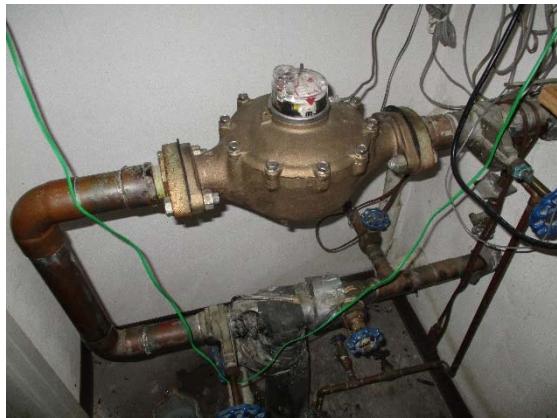
The cold water distribution systems serving the building addresses appear to be interconnected and are fed from a single meter. During the site visit a leak was observed at the water meter and needs to be repaired immediately. There is one electric water heater serving the kitchen. Both hot and cold distribution systems are

predominately constructed of copper pipe which has exceeded the useful life expectancy and should be replaced during any future renovations. (Photo P-1)

P-1: Water Meter

A domestic water service lateral enters the building from the street and is located in a closet in administrative office area of the building. During our site visit the service is leaking and should be fixed immediately. This water service lateral is constructed of galvanized and copper pipe and has far out lived it's useful life and is under sized for the number of fixtures it is serving. This water service lateral and meter serves the entire building. It is barely fulfilling the cold water demand of the building at the current time. This lateral will most likely be required to be replaced to meet water demand calculations of the current Wisconsin administrative plumbing code if there are any future major renovations of the building. (Photo P-2)

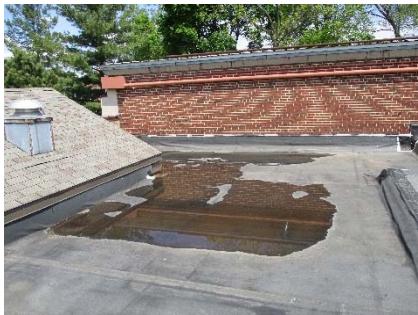
The storm/roof drainage system collects the storm water from the roofs and conveys it to the existing City of Beloit exterior storm water systems. The roof drain system is constructed of cast iron pipe and fittings and appears to be in satisfactory condition even though it has outlived the expected useful life of the cast iron material.. Although most of the roof drain system is concealed it appears that no immediate replacement of the piping is necessary. The roof drains however are showing signs of corrosion and should be replaced with future roof replacement. There is built up debris around most of the roof drains which is causing a slower roof drainage. These drains should be immediately cleaned of debris. (Photo P-2, P-3, P-4)

P-3 Standing Water

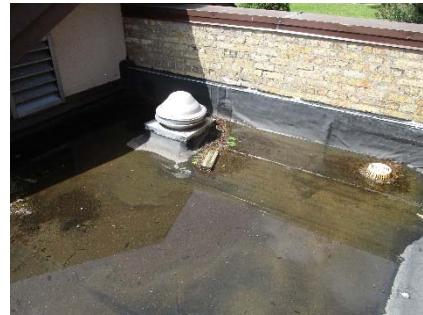
P-4: Roof Drain with built up debris

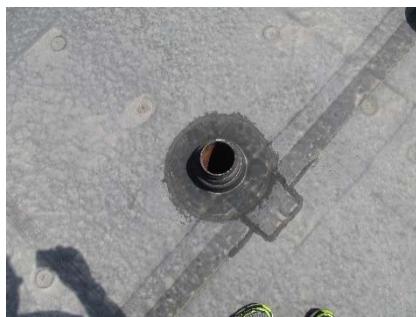
P-5: Cast iron roof vent pipe

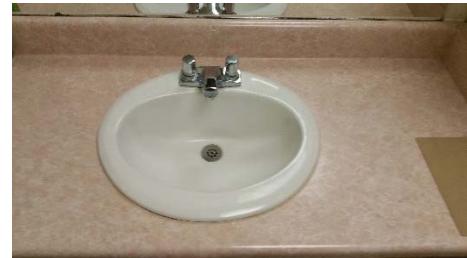
The fixtures throughout the building are outdated and not water conservative. During field visit the hot water was not functional in the rest rooms. Most of the fixtures are not ADA compliant. The water supply shut off valves are probably not operational due to rust and deposits from the corroded galvanized and copper pipe. The restroom spaces are not ADA compliant. Most of the water closets are round front and do not comply with current Wisconsin plumbing and building code requirements for public rest rooms. All the fixtures should be considered for replacement during future renovations.

P-15: Non-ADA compliant lavatory
